METEOROID AND DEBRIS IMPACT FEATURES DOCUMENTED ON THE LONG DURATION EXPOSURE FACILITY

A Preliminary Report

Compiled by Members
of the LDEF Meteoroid
and Debris Special
Investigation Group

Space & Life Sciences Directorate
Solar System Exploration Division
Planetary Science Branch
Publication # 84
JSC # 24608

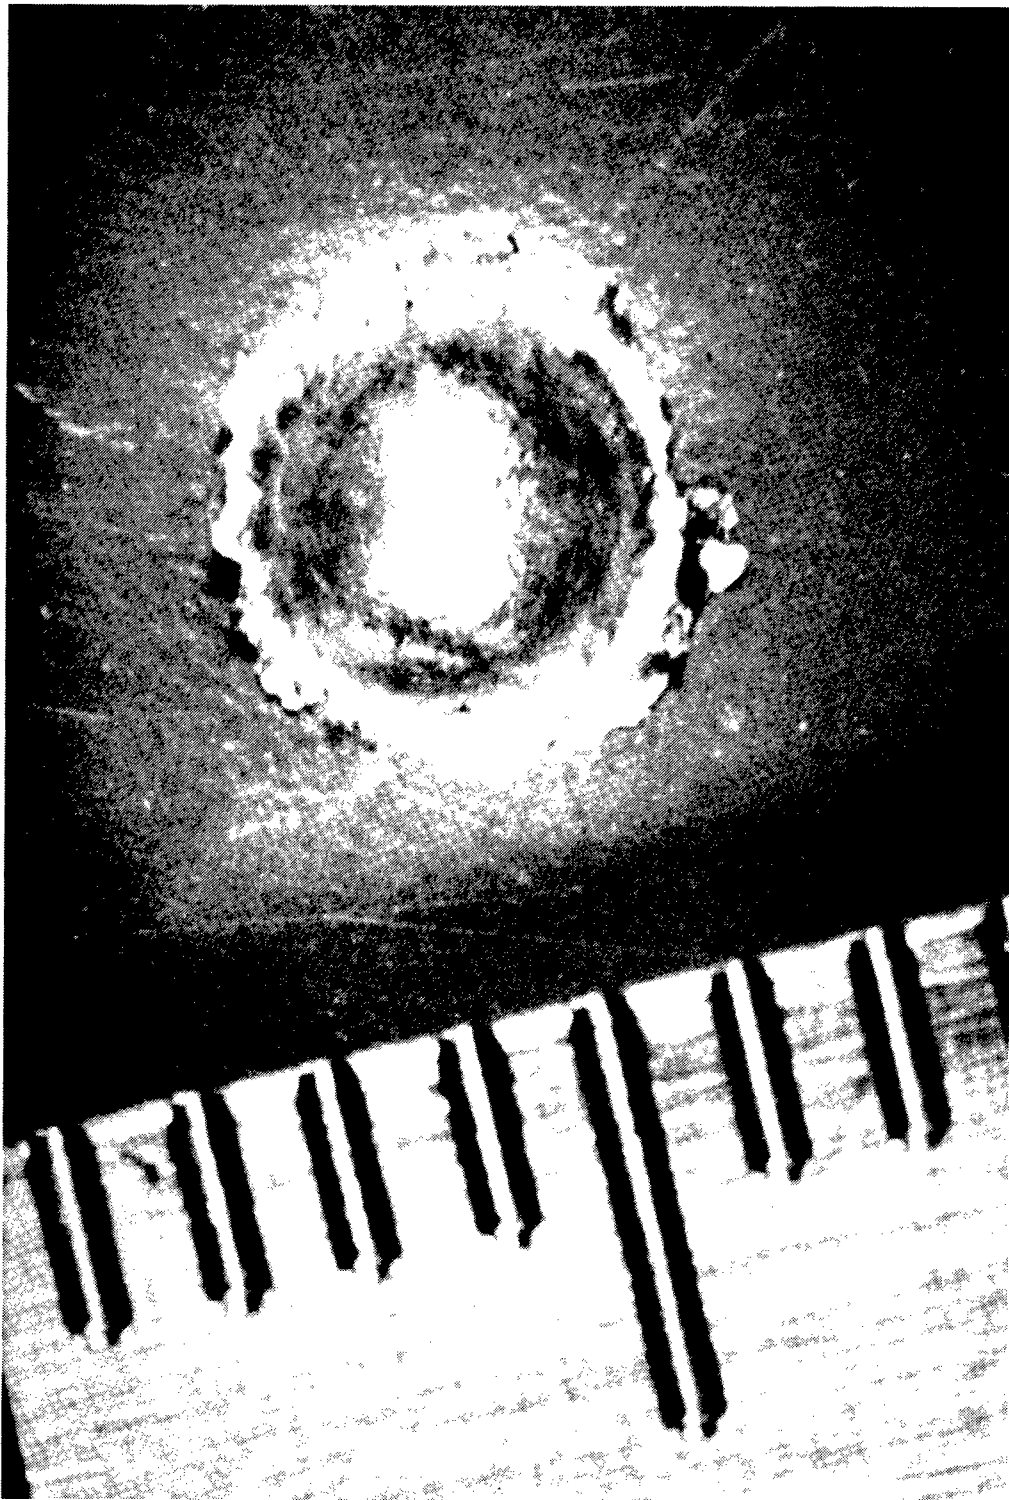
Figure 2. Photograph of a symmetrically-shaped crater in an aluminum surface. Most features on LDEF were of this type. Small divisions on scale are in millimeters.

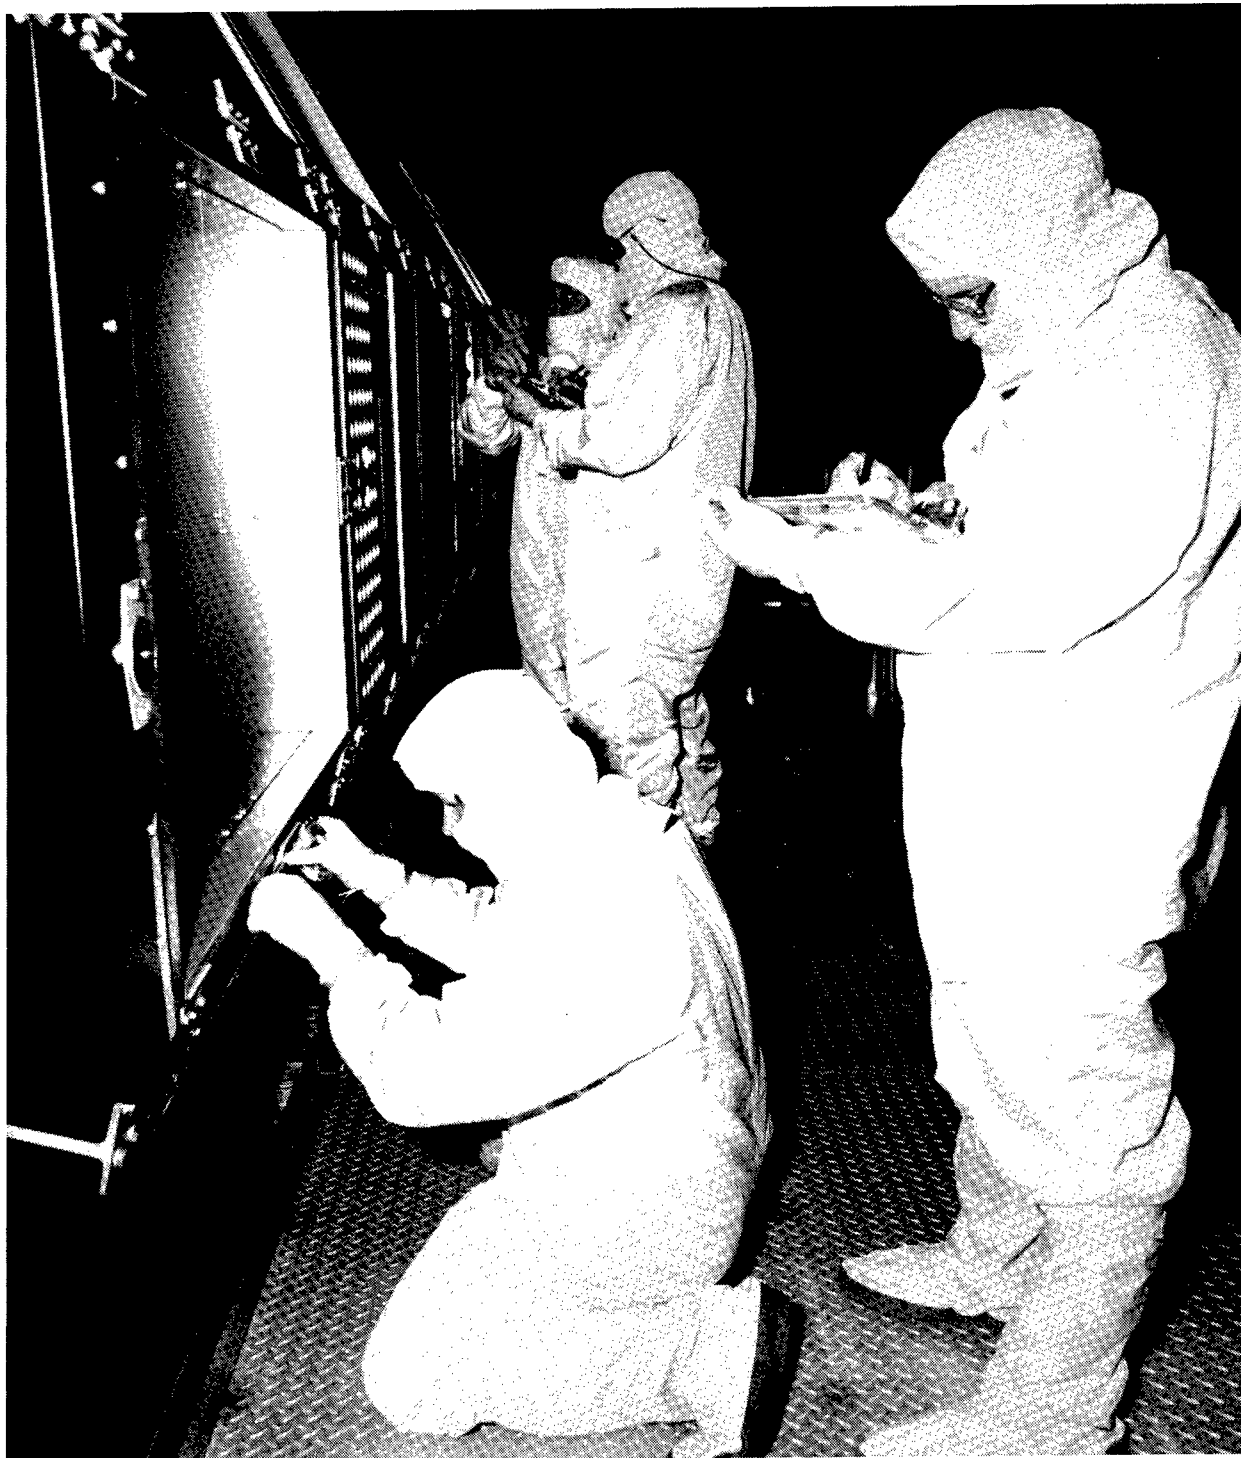
Figure 21. Members of the M&D SIG performing the BOLTS, CLAMPS, SHIMS, AND EXPERIMENT TRAY FLANGES/LIPS INSPECTION AND BOLT ORIENTATION SURVEY prior to the commencement of the deintegration operations.

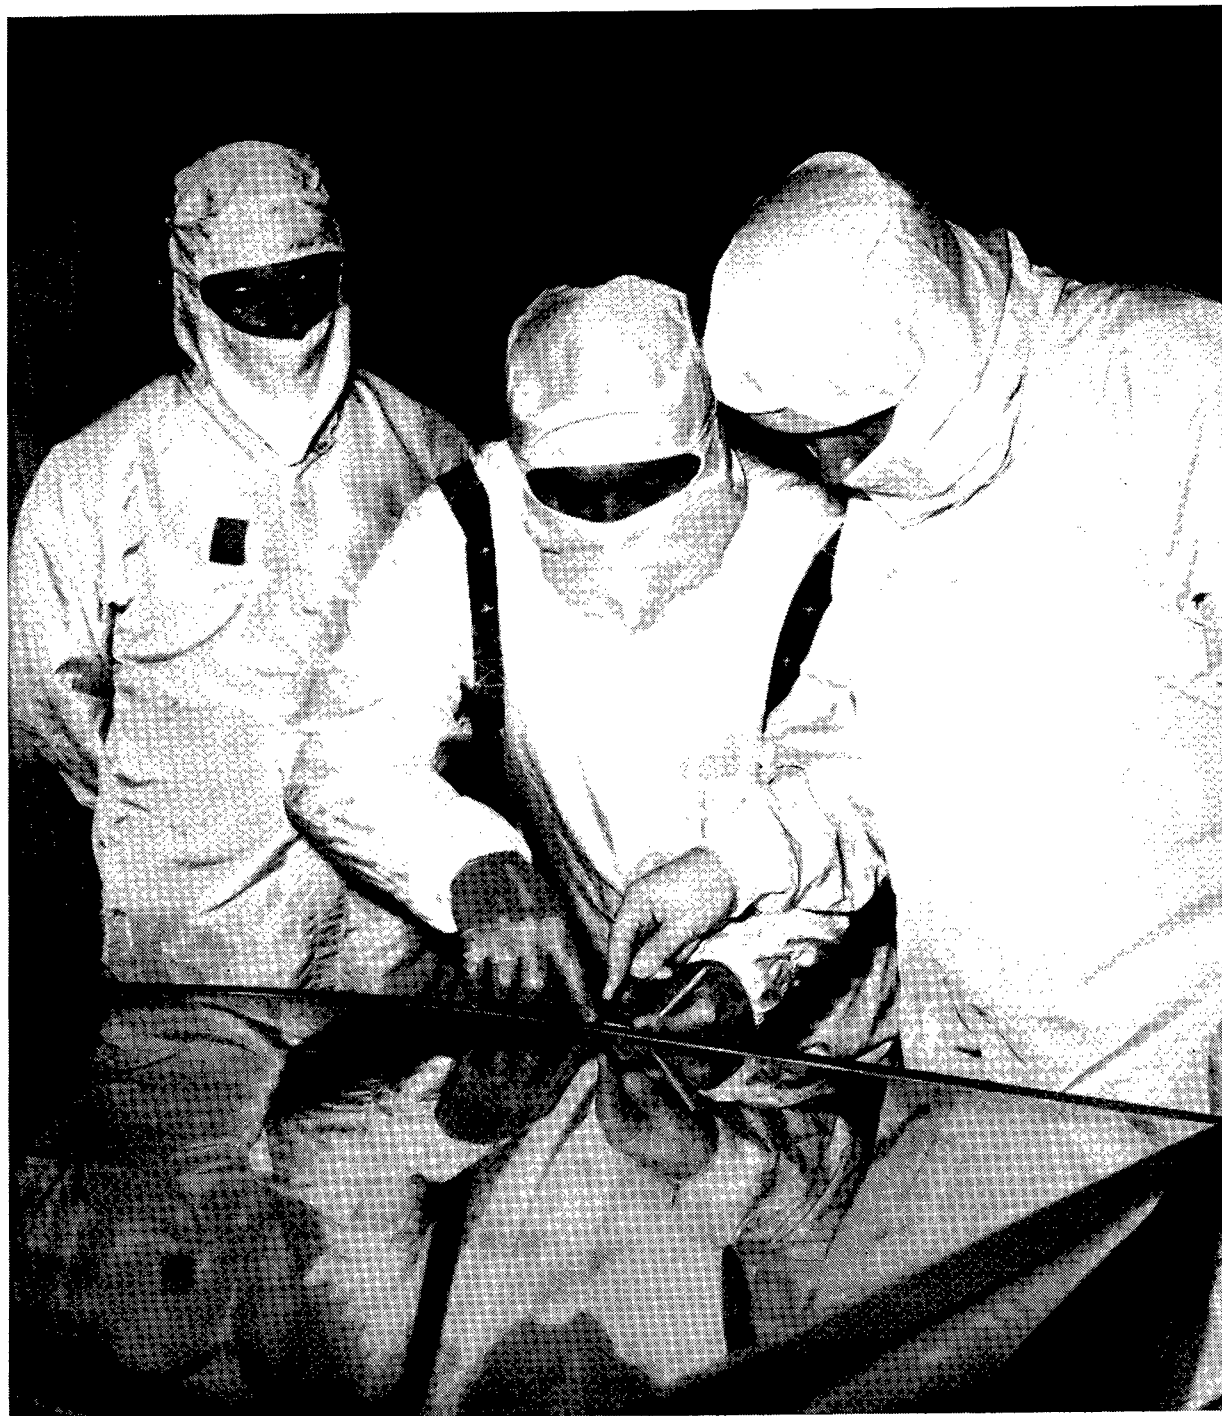
Figure 23. M&D SIG and Ground Operations personnel removing small sections of the experiment-tray cover gasket to prevent damage and contamination to features residing on the experiment-tray flanges.

The final step of the on-spacecraft inspection involved cutting a small section out of the rubber experiment-tray cover gasket in those places identified by the M&D SIG which could damage features of interest. Permission to make these cuts was sought from each experiment PI, and in most cases was granted. The actual gasket cutting took place in the outer air-lock of SAEF II and was carried out by M&D SIG- and Ground Operation personnel working in unison (Figure 23, also see NASA photographs KSC-390C-1214.03). The exact location to cut the gasket was measured from the experiment-tray cover bolt hole nearest to the feature (see above). A small section of the gasket was then removed with a scalpel from either the inner, central, or outer portion of the gasket strip. By not trimming the gaskets across the entire cover-gasket strip, the experiment-tray cover could still seal with the experiment-tray flange preventing contamination from reaching the experimental surfaces. Once this task was completed, the individual experiment-tray covers were attached to the appropriate bay location by Ground Operation personnel.

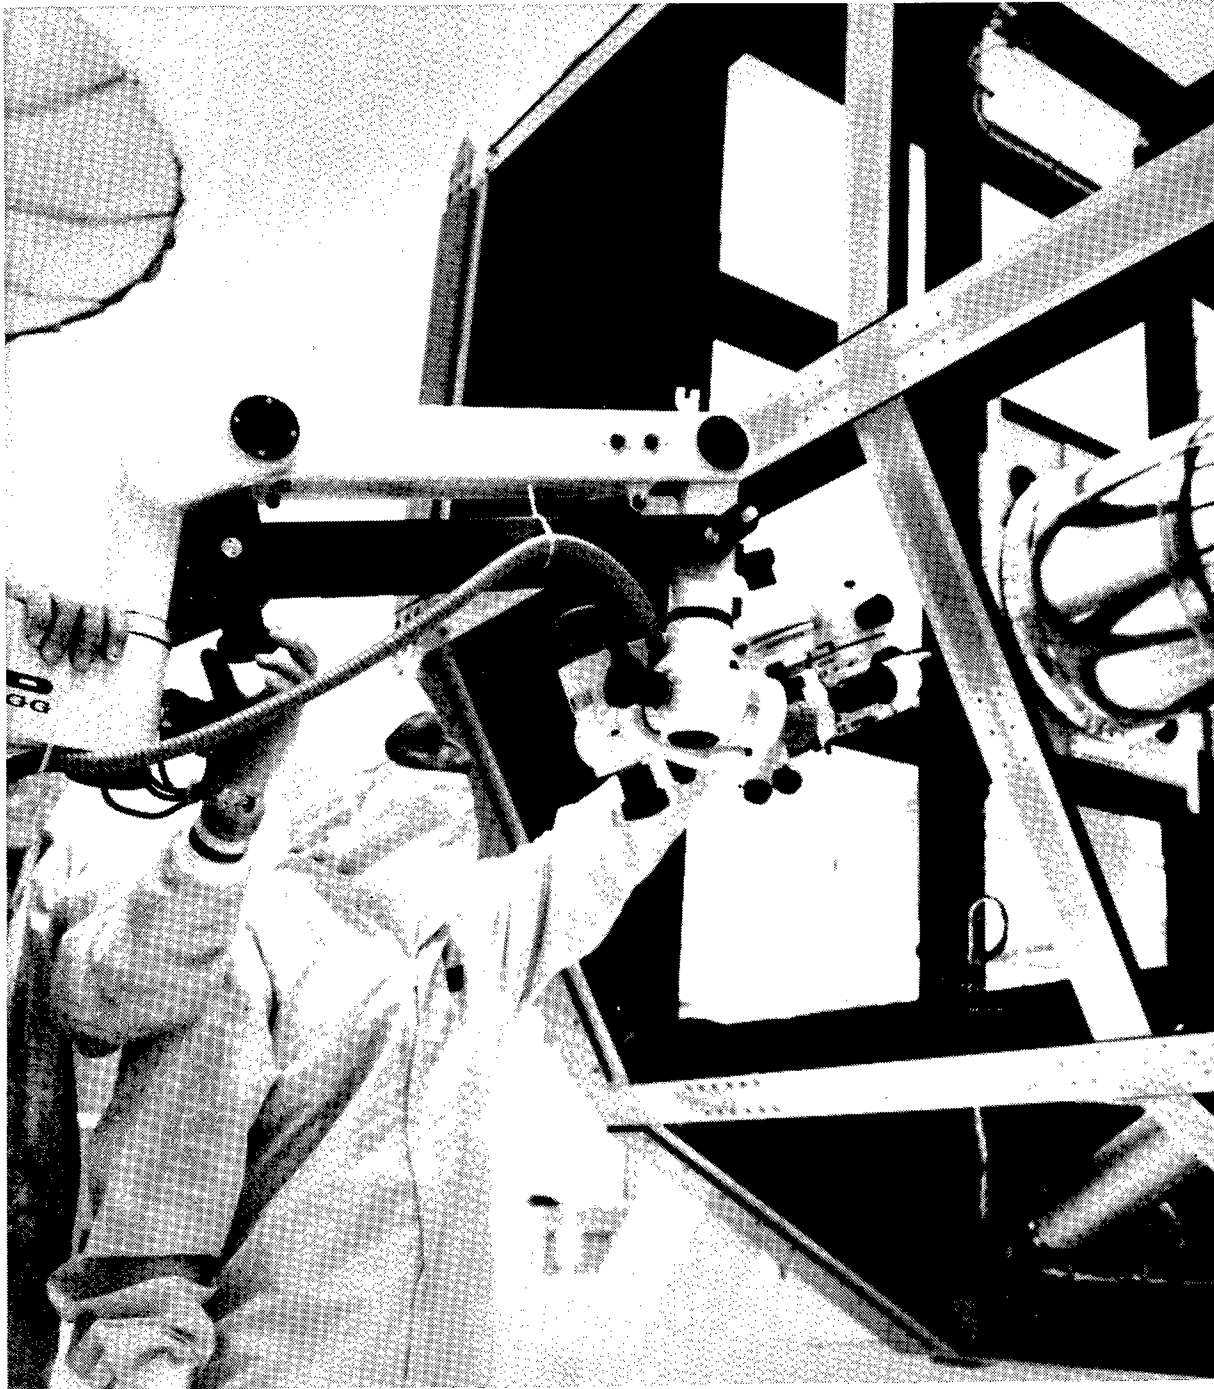
Figure 33. Members of the M&D SIG A-Team shown configuring one of the Stereo-Microscope Imaging Systems for photodocumentation of the LDEF structural frame. Note the dark discoloration of the space-exposed areas on the structural-frame members.

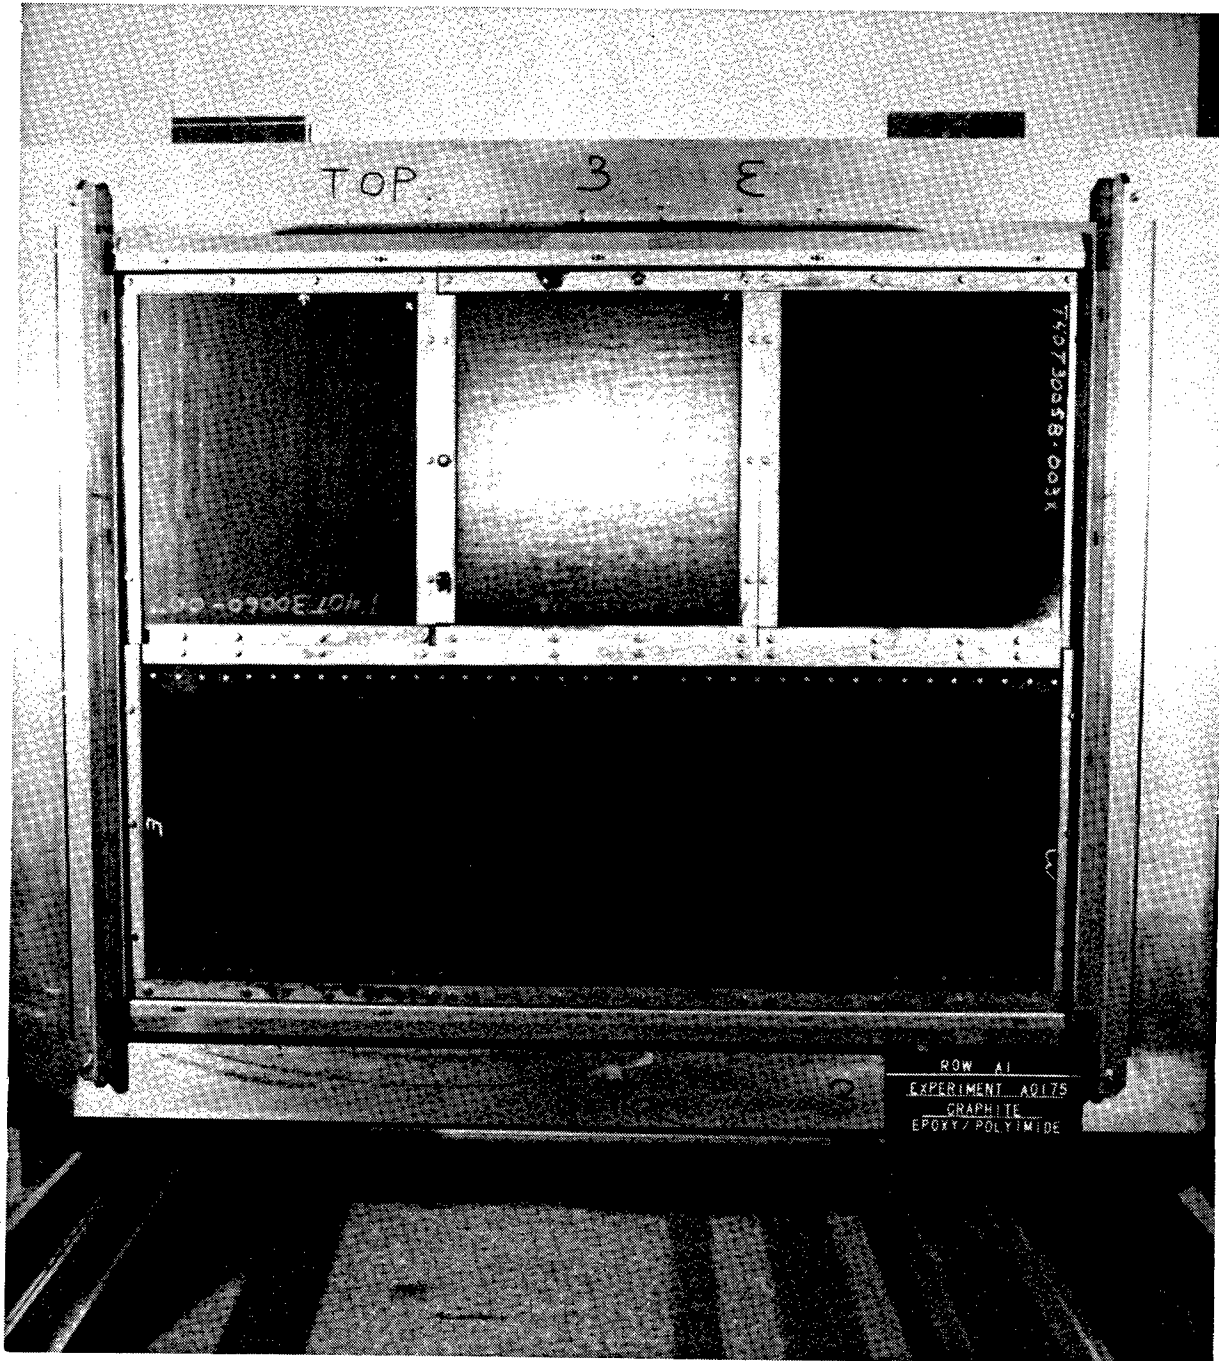
Figure A01-1. This post-deintegration view shows the front of the entire A01 experiment tray.

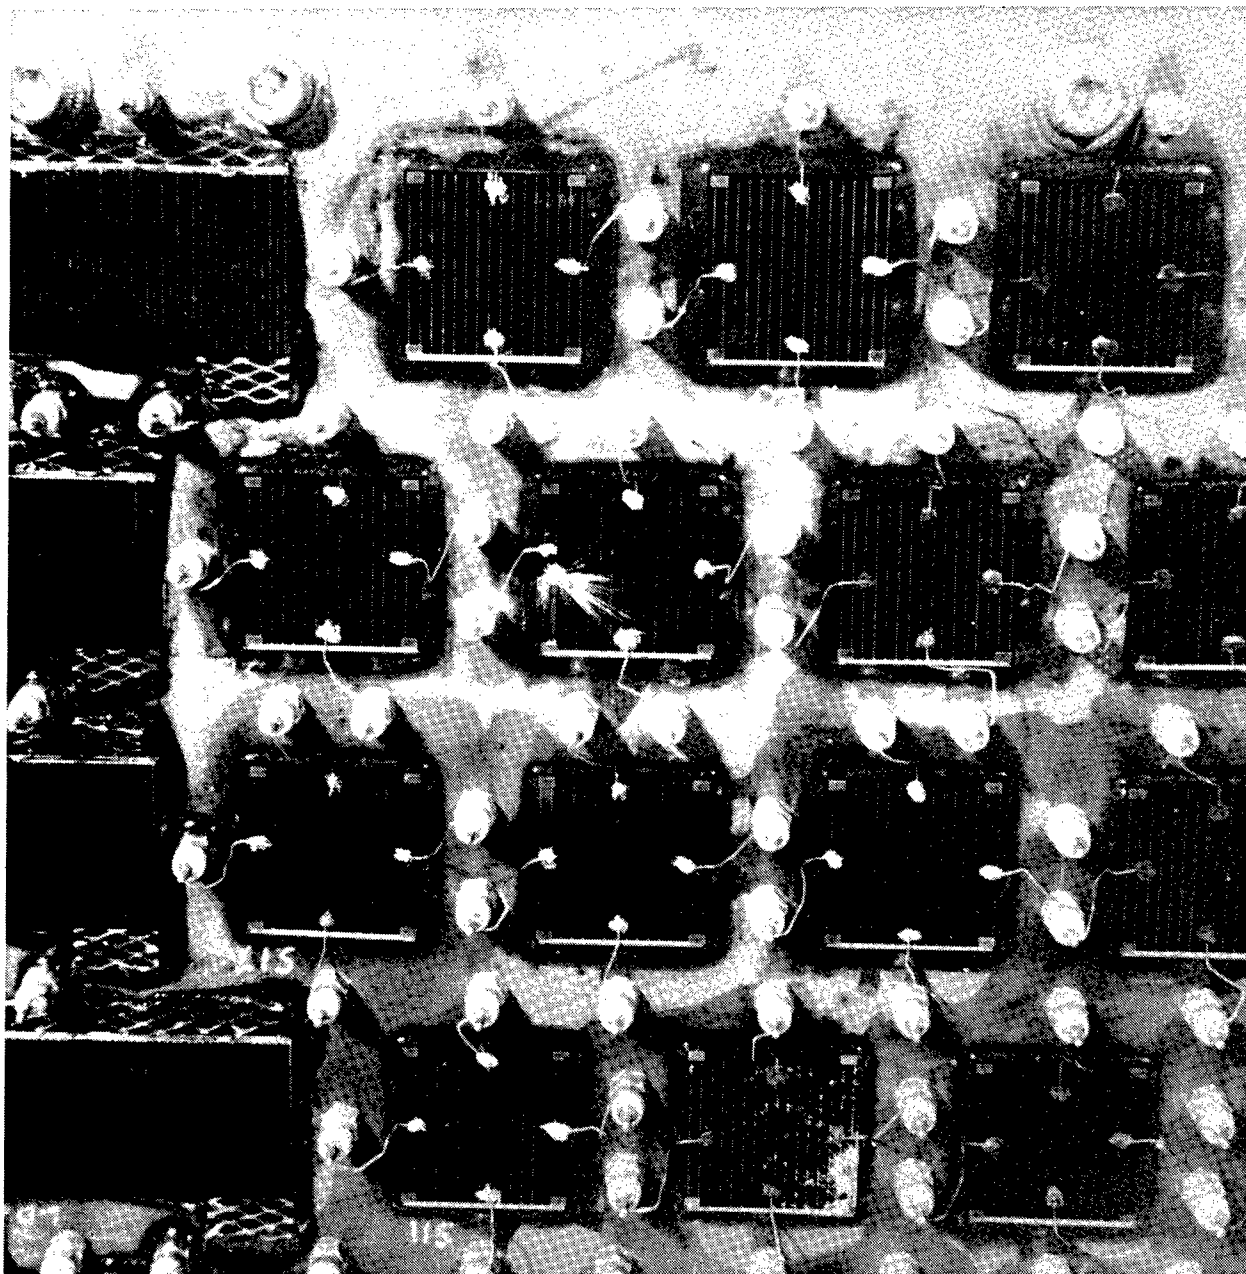
Figure A08-2 - This is a close-up of the sub-tray in the lower left of tray A08, showing an impact feature on a solar cell. This view measures approximately 13 cm across.

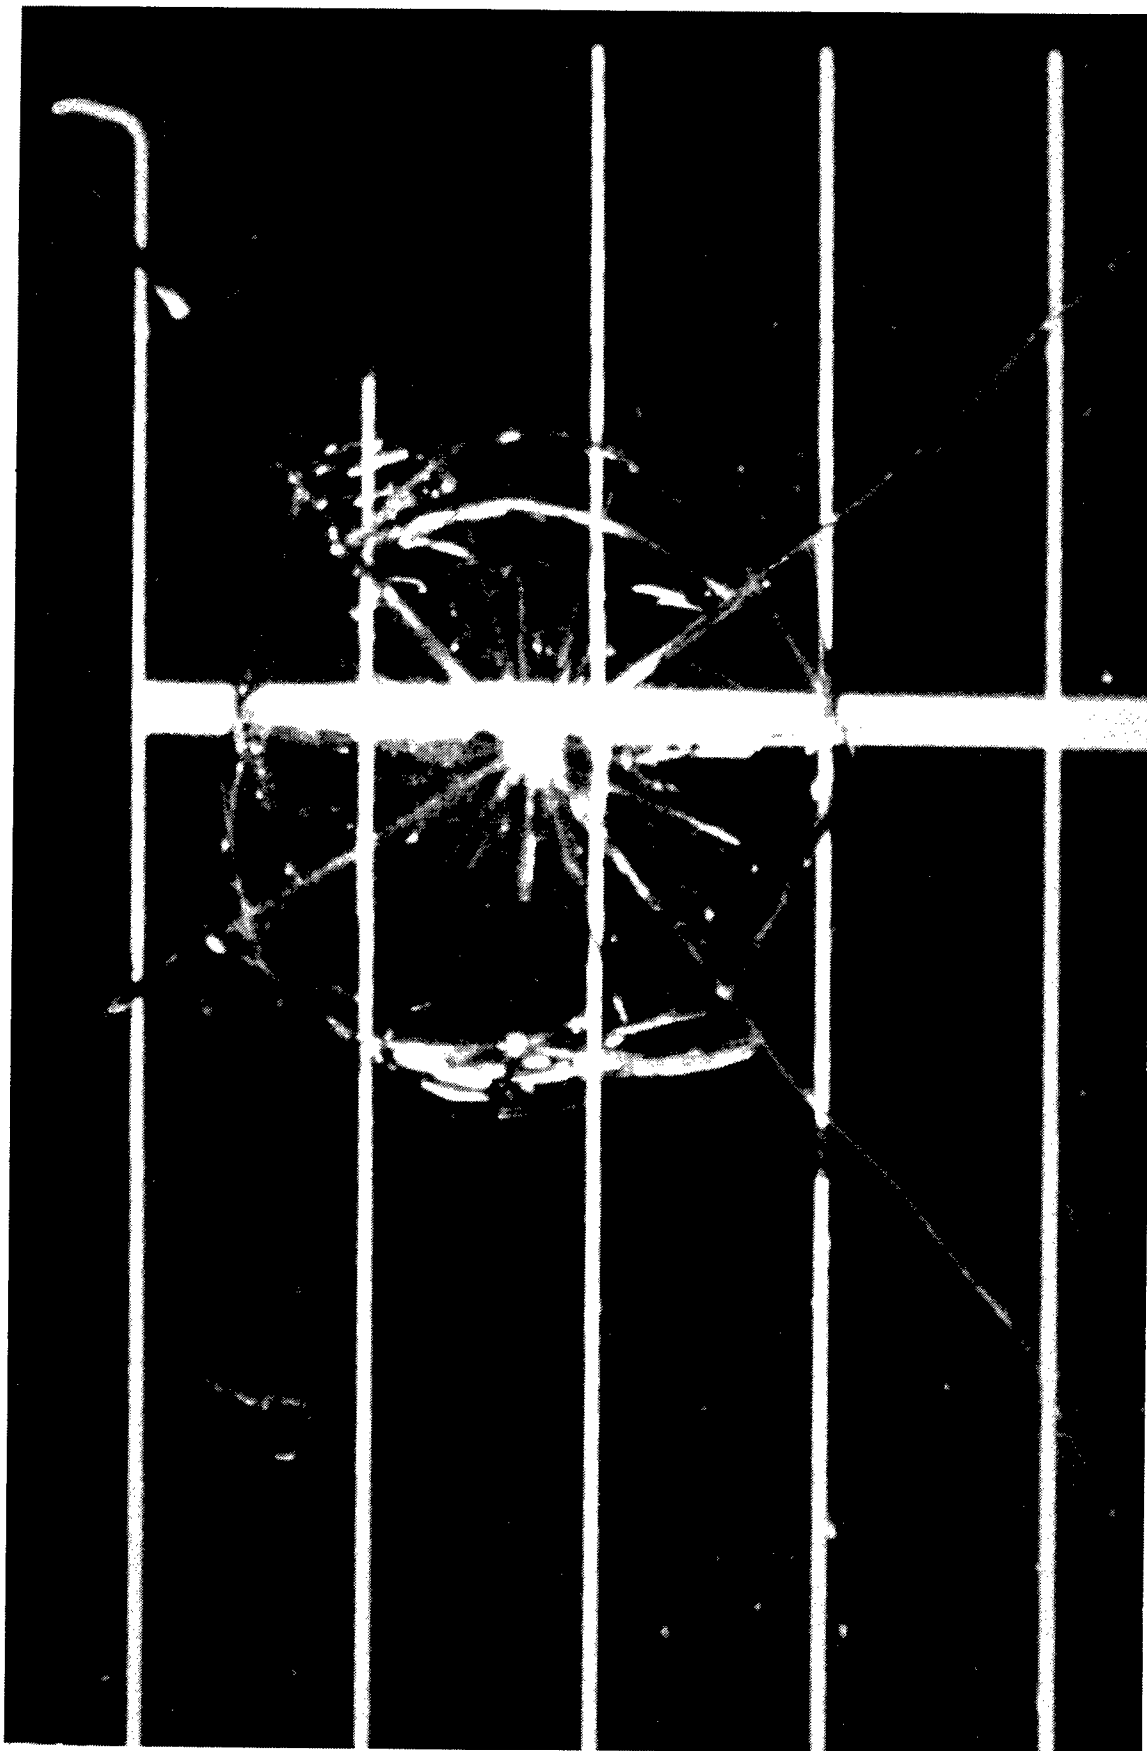
Figure A08-3. This is a close-up on an impact into a solar cell, showing accompanying shattering, and measures approximately 3 cm across.

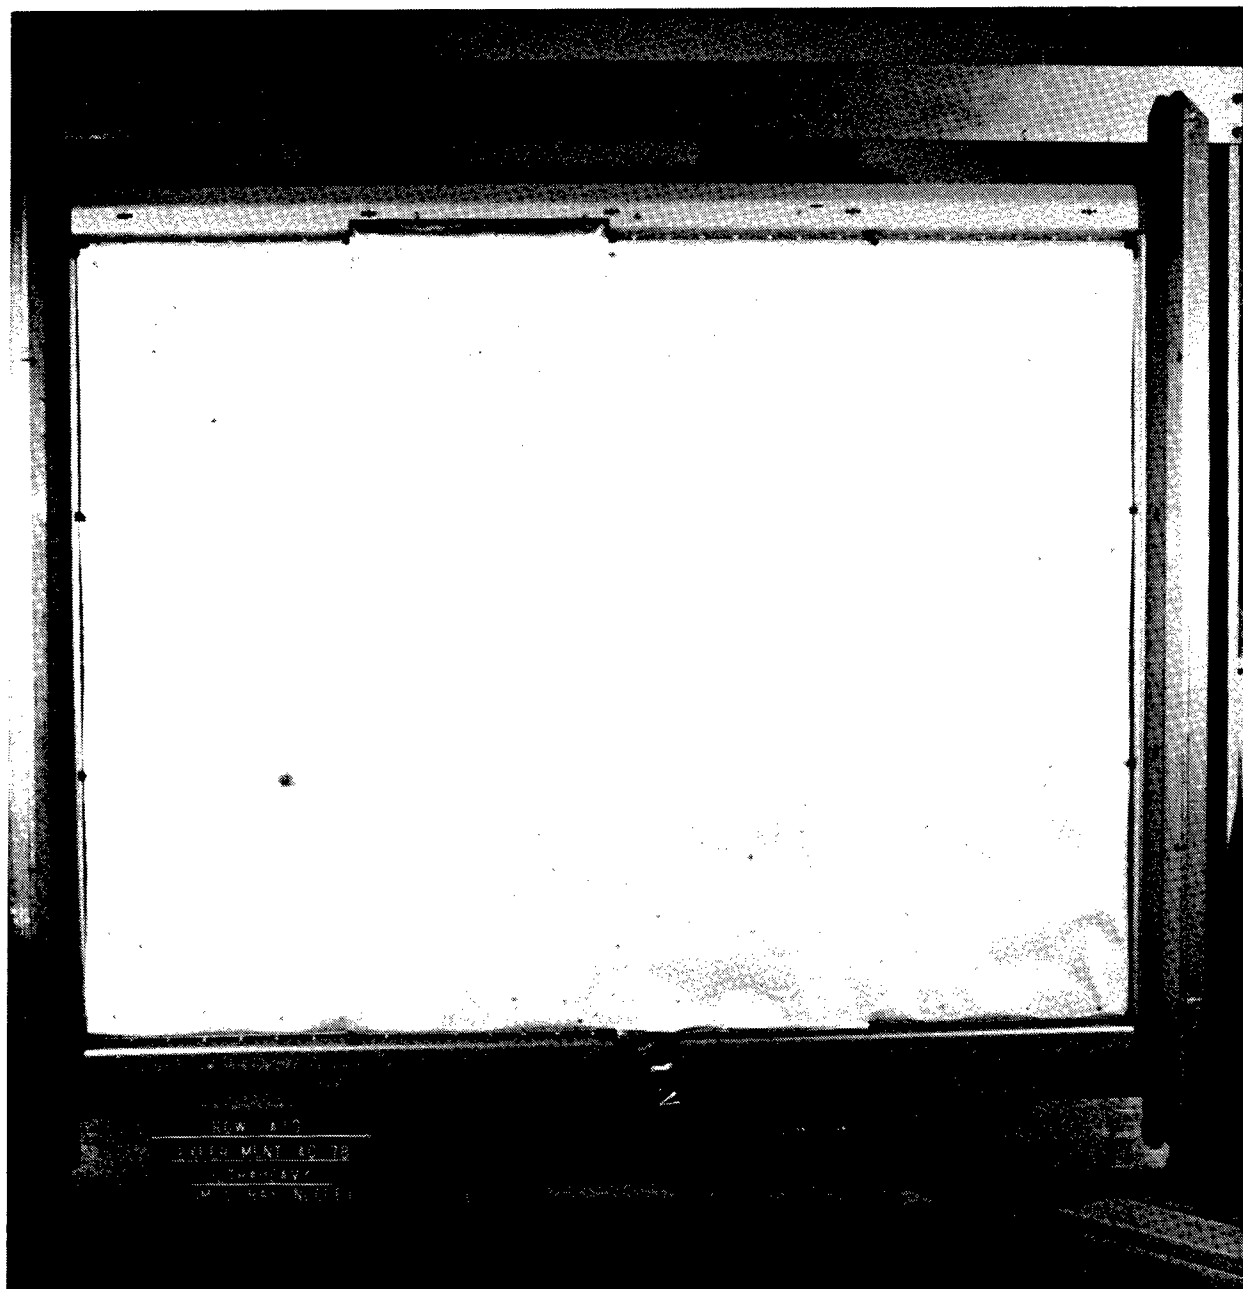
Figure A10-1 - This post-deintegration view shows the front of the entire A10 experiment thermal blanket. *Fleur-de-lis* patterns across the blanket are surface expressions of the velcro attachment points to the underlying aluminum frame. Many impact features are apparent across the blanket surface. The large impact feature in the lower left is also shown in Figure A10-2.

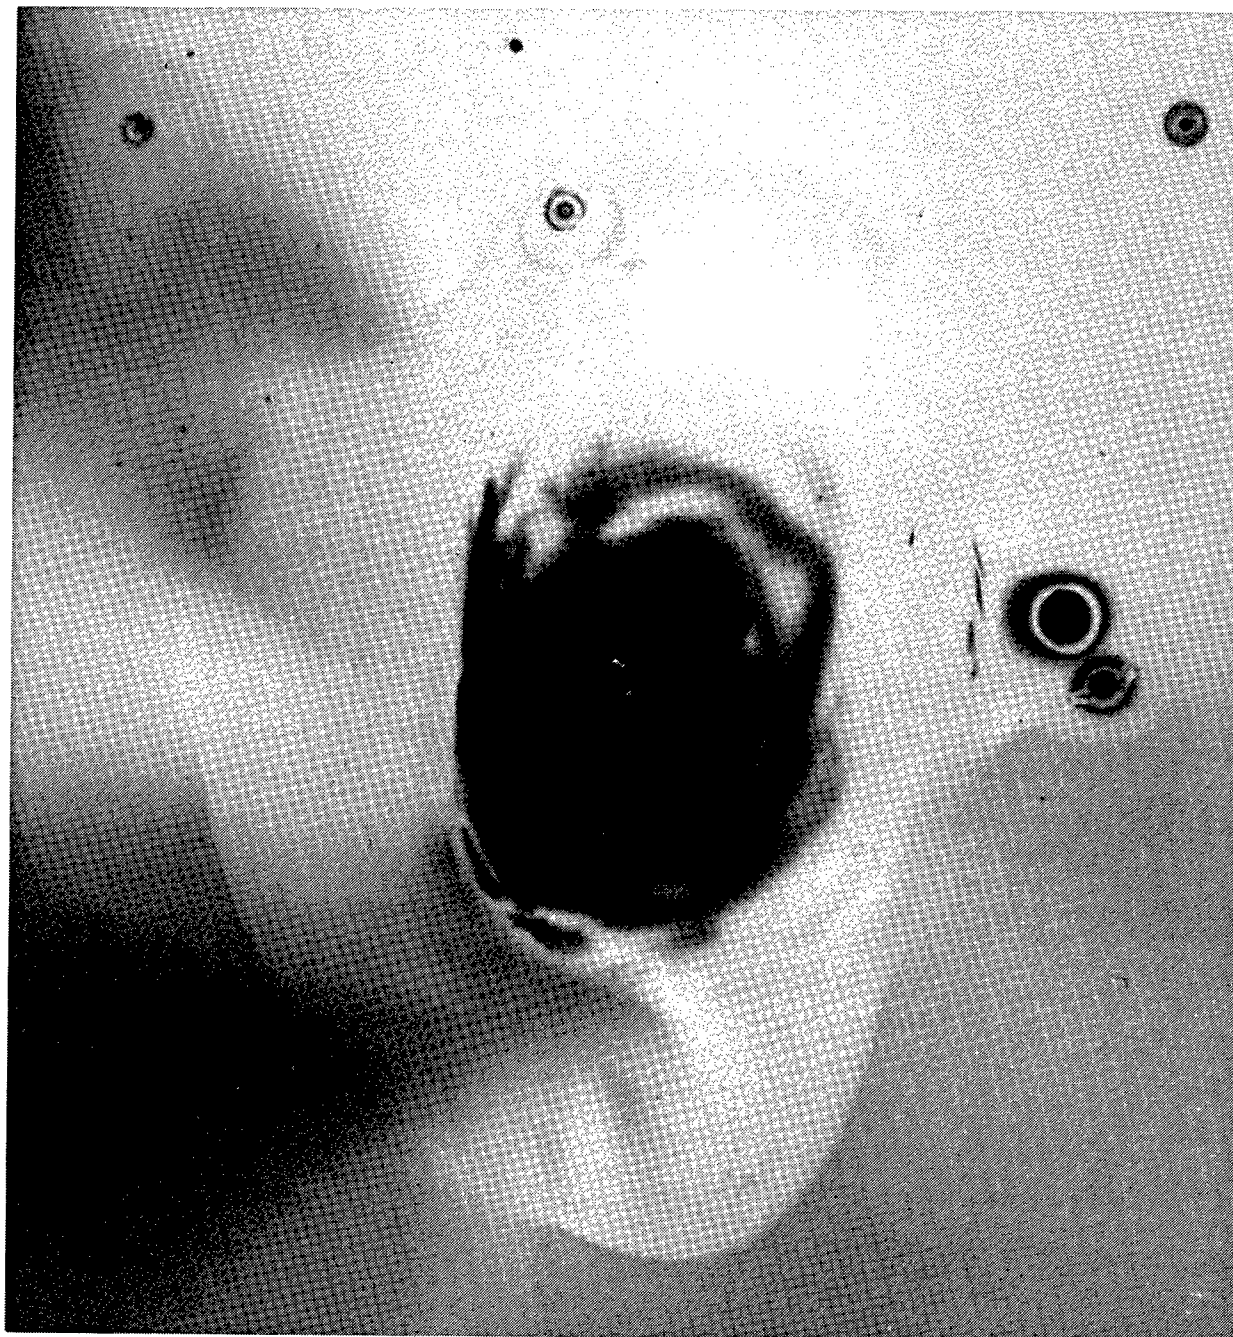
Figure A10-2. This is a view of large impact features on the A10 thermal blanket. Dark rings encircle many of the features. Some rings are incomplete. Rounded delamination areas surround most impact features shown here. View measures approximately 10 cm across.

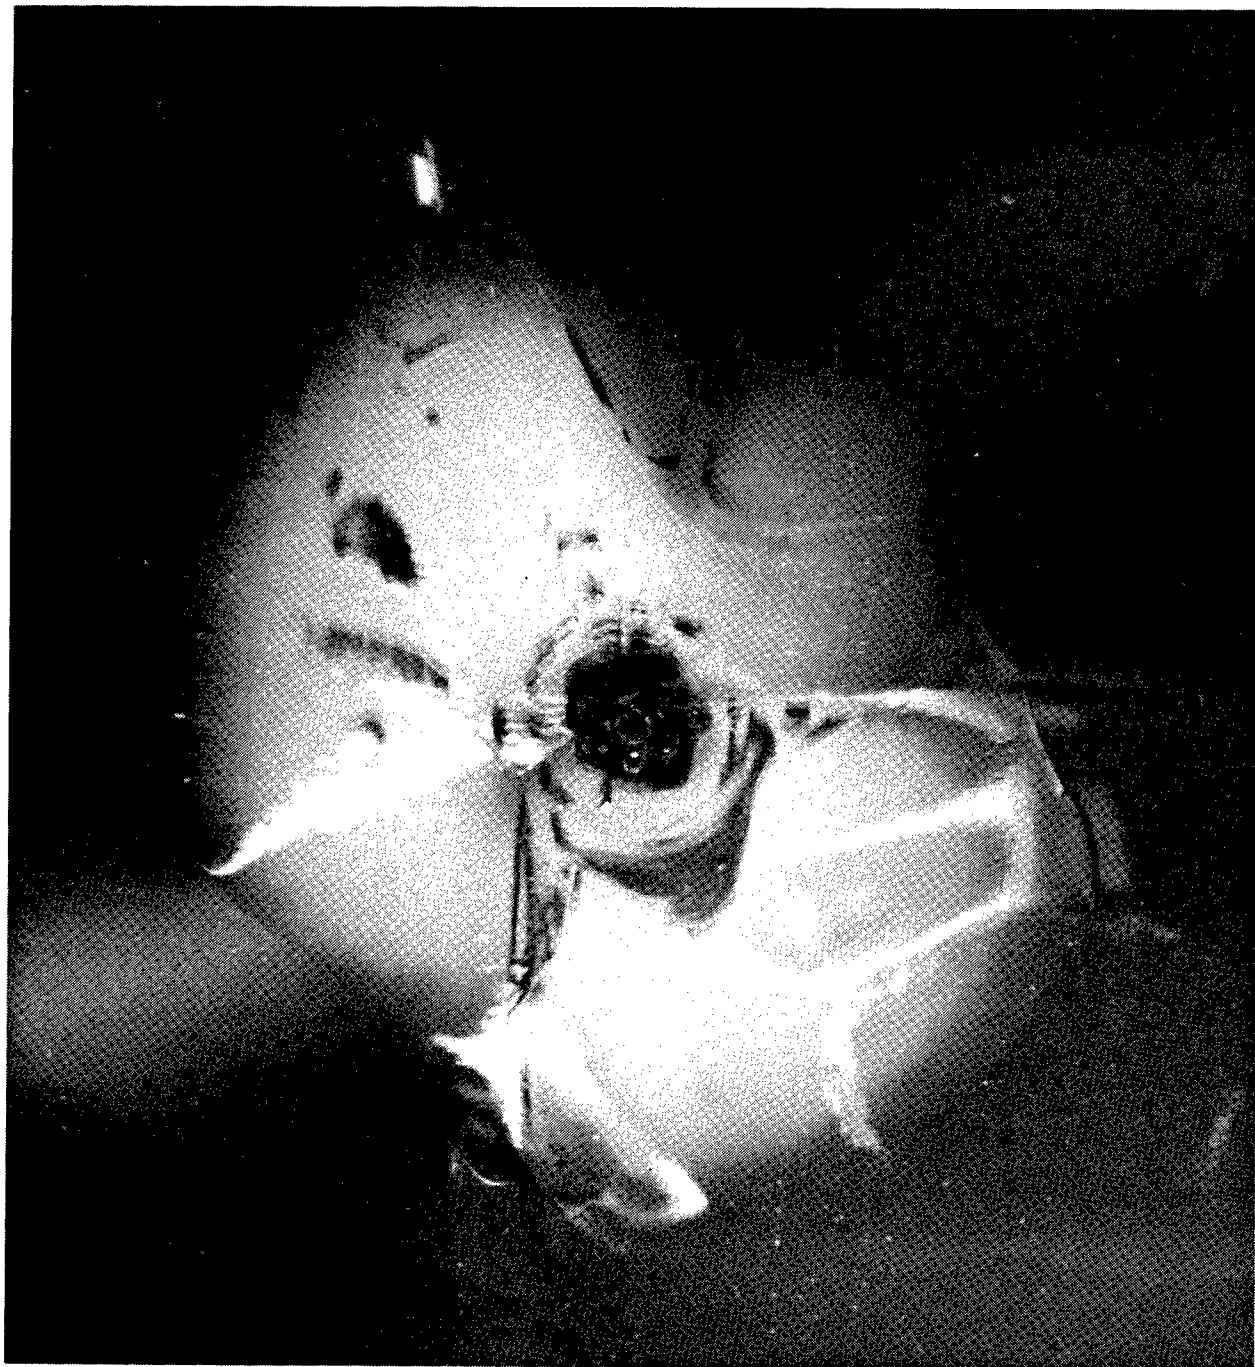
Figure B07-1. This is a view of one large impact feature on the B07 thermal blanket. A rounded delamination area surrounds the impact feature shown here, and the penetration hole is not spherical, possibly reflecting deformation of the Teflon surface. View measures approximately 10 cm across.

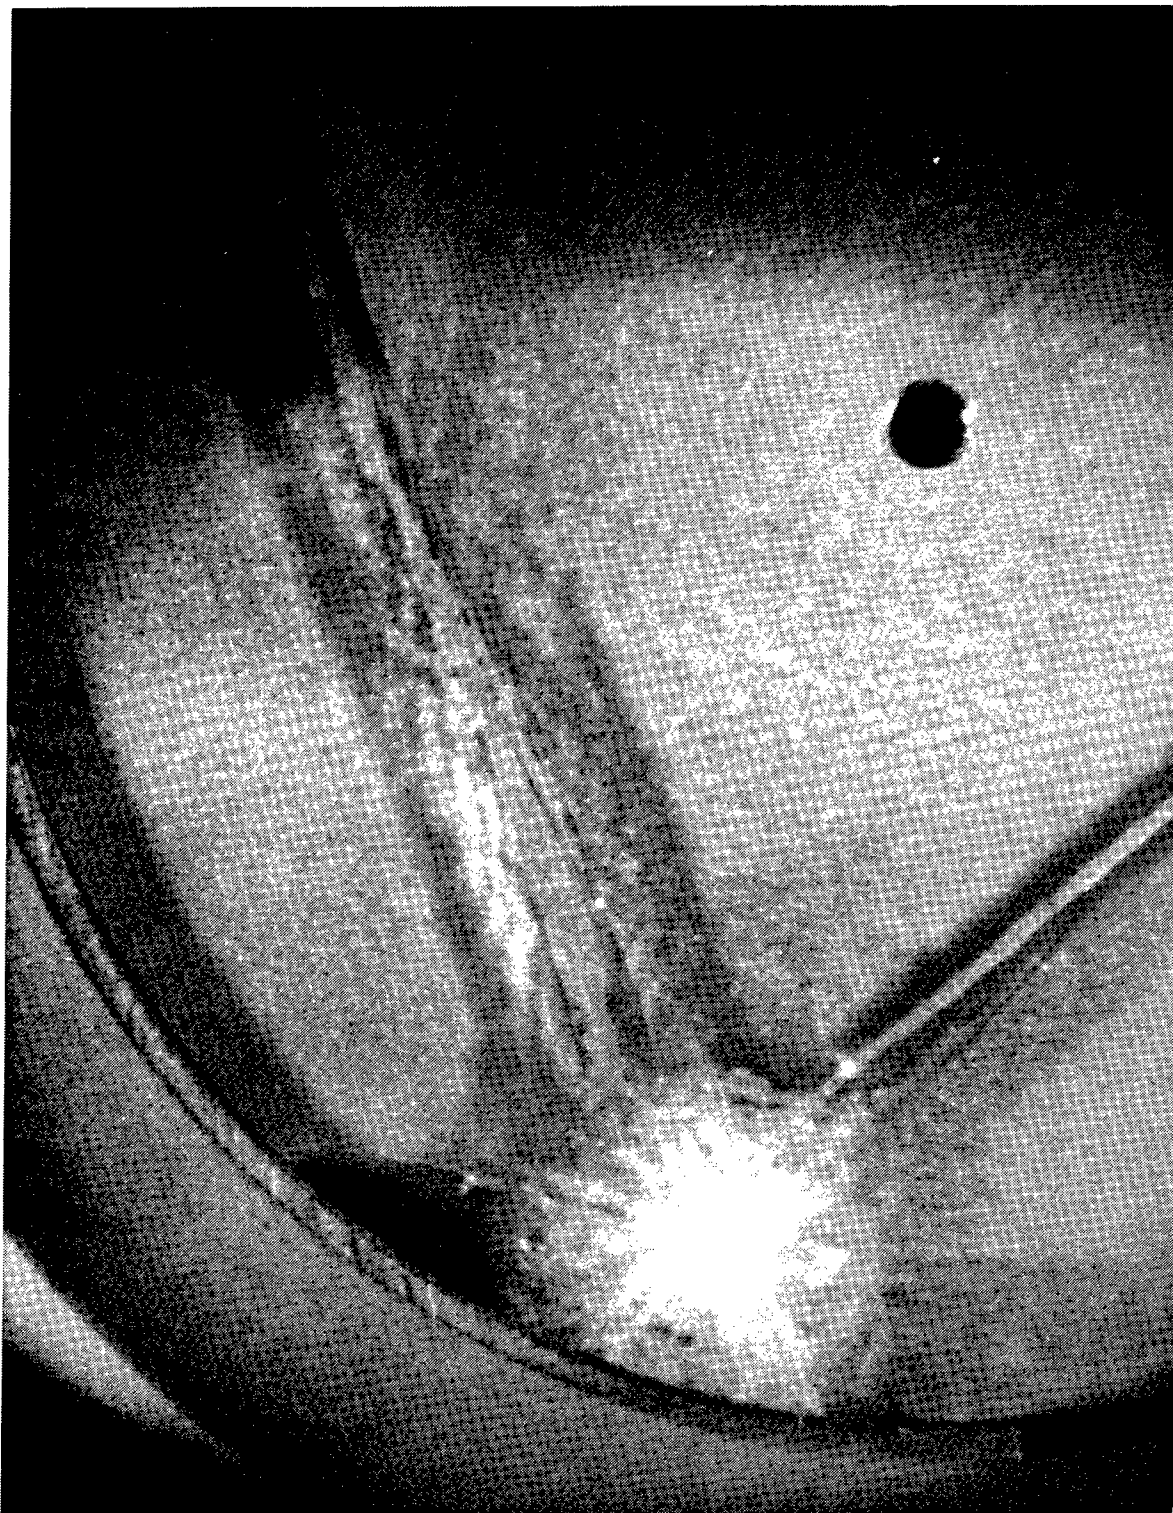
Figure B08-1. This is a view of one large impact feature on an optical surface from tray B08. Large radial cracks extend across the entire surface of the sample, and the "crater" consists of finely-shattered material. View measures approximately 2 cm across.

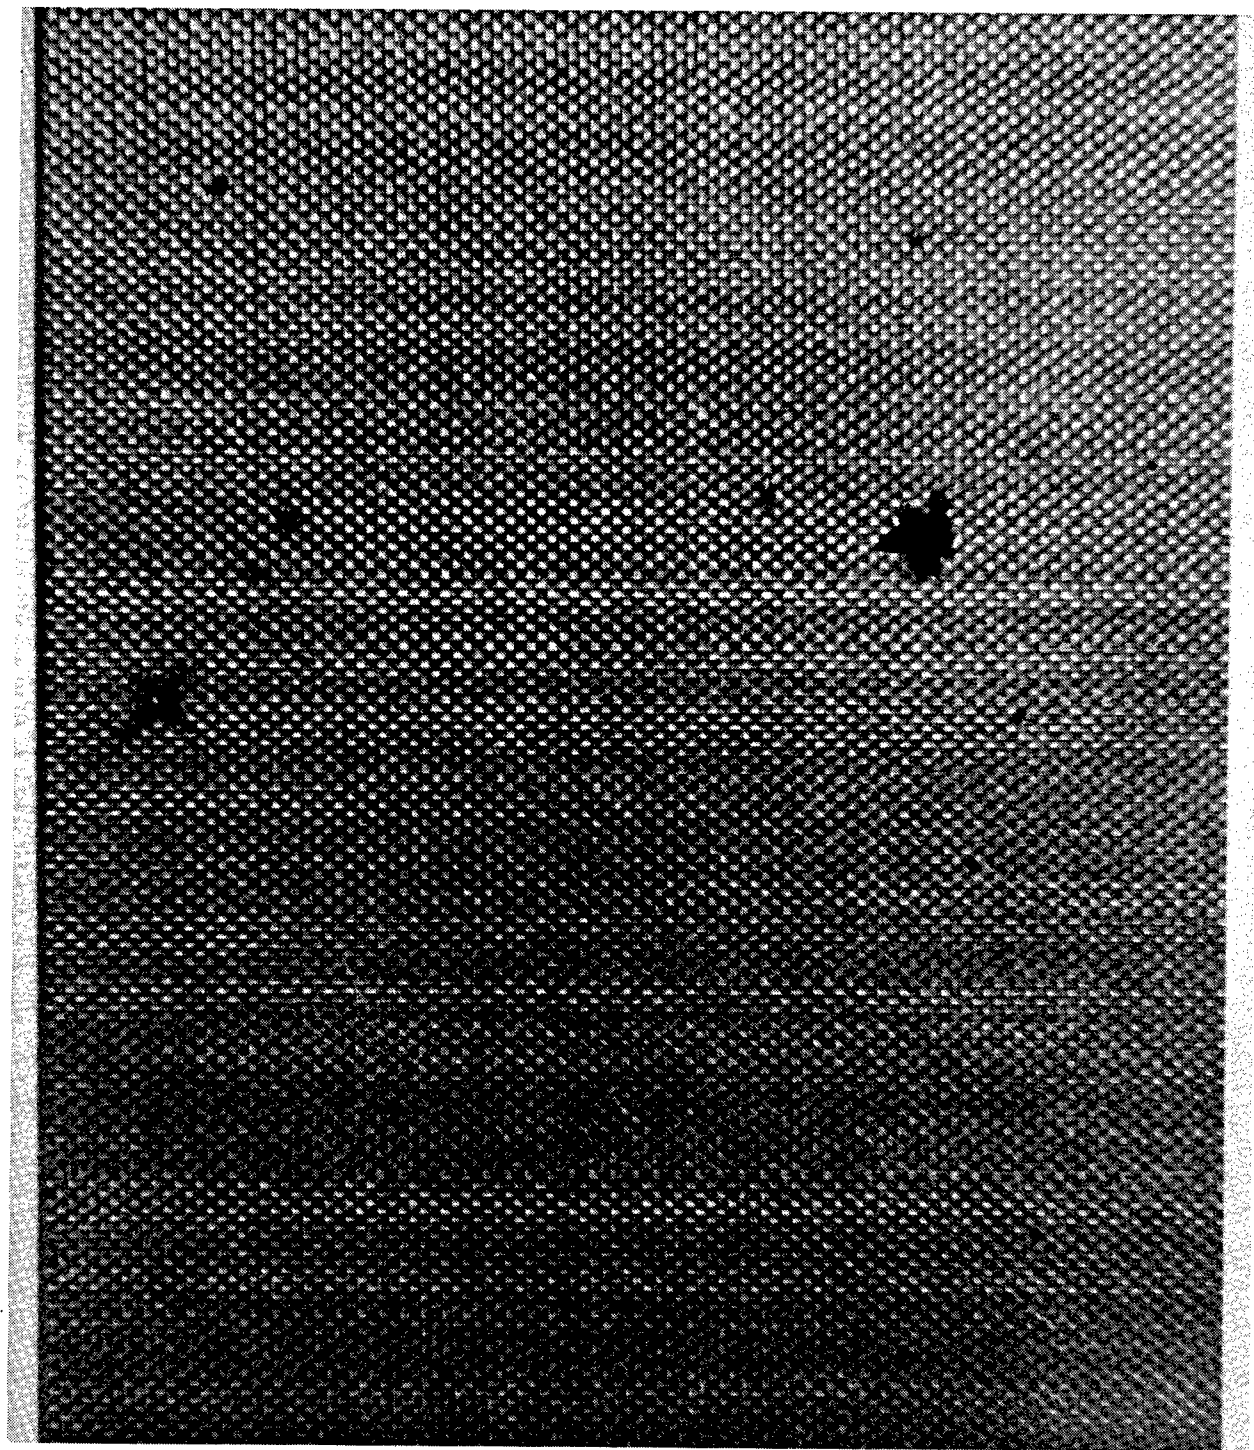
Figure B09-2. This view shows impact features in the fabric material of Tray B09. View measures approximately 4 cm across.
